THE IDENTIFICATION AND
CONSERVATION OF THE INTERIOR
ARCHITECTURAL PLASTICS
AT DRAGON ROCK

Historic Preservation

**MATERIALS AND CONDITION SURVEY:
INTERIOR PLASTIC COMPONENTS AT
DRAGON ROCK IN GARRISON, NEW YORK**

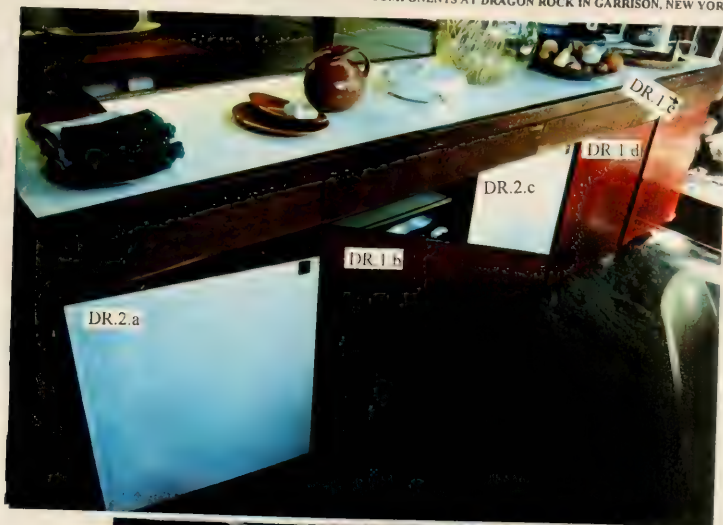
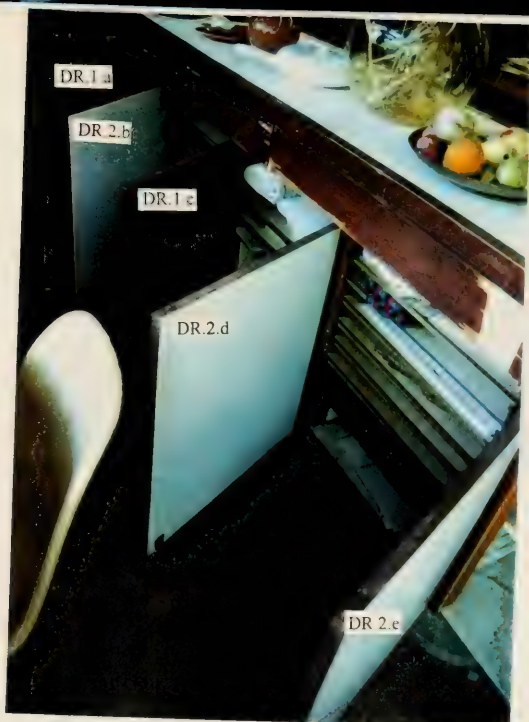
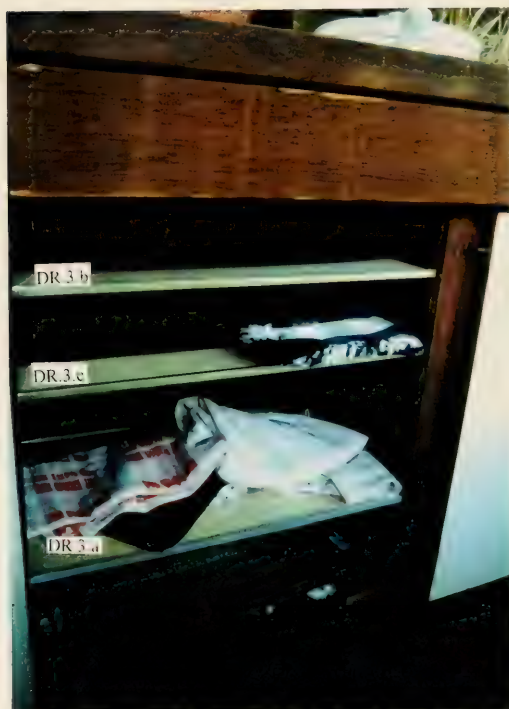
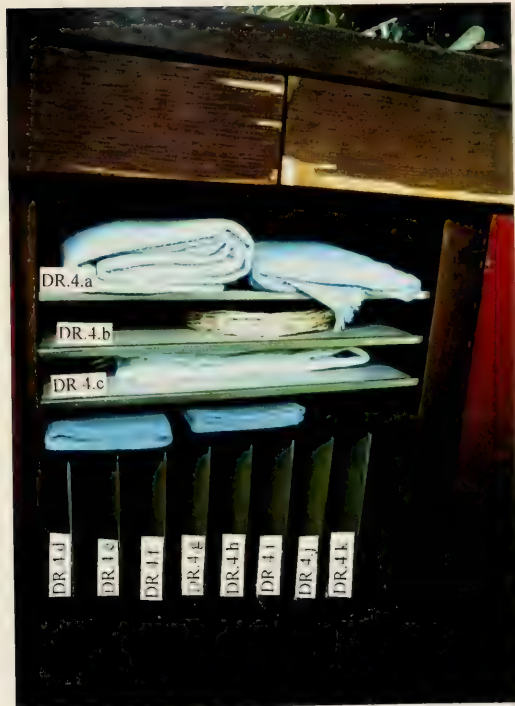
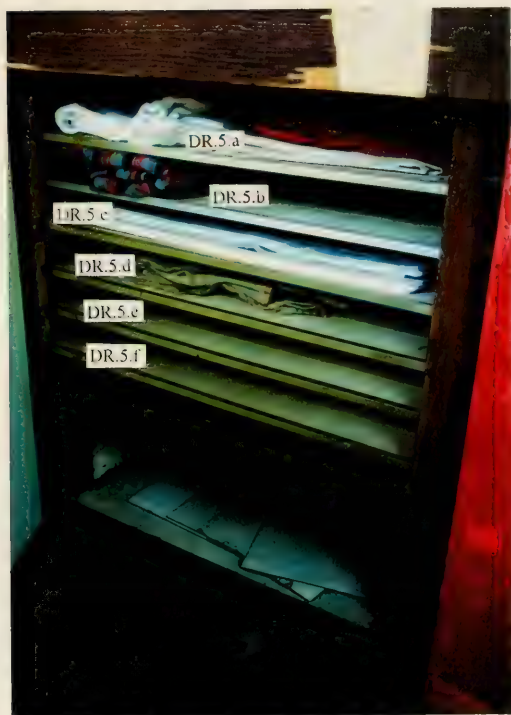
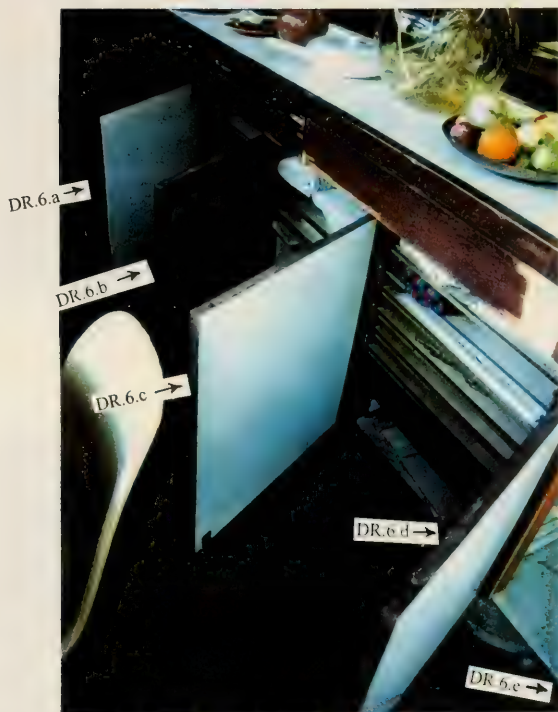
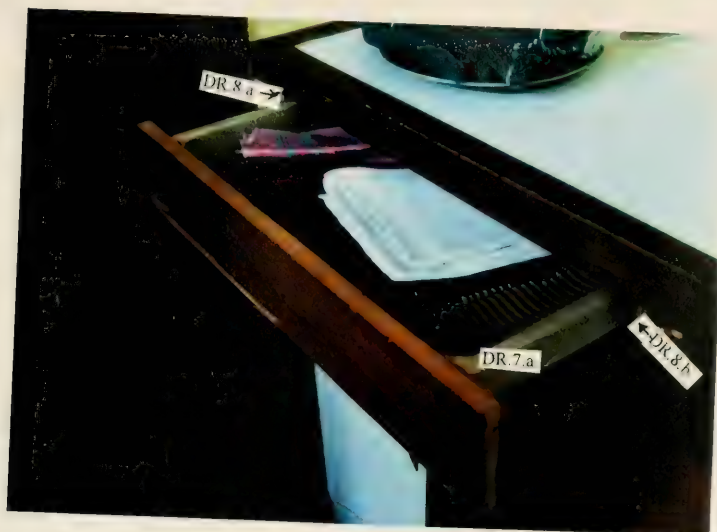
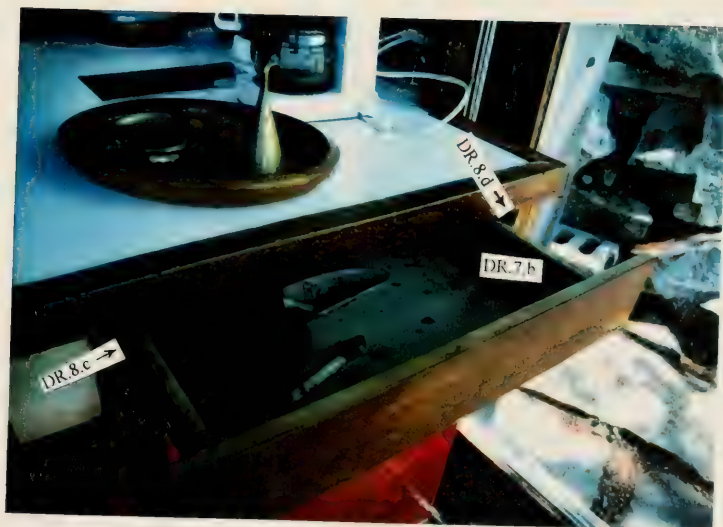
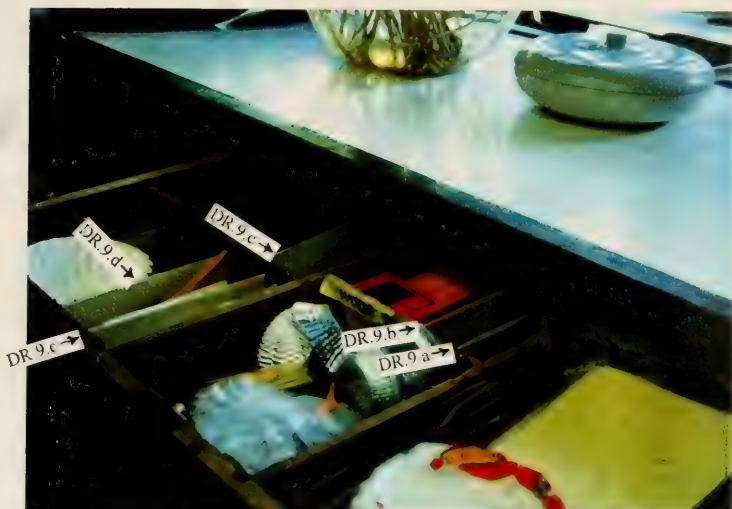
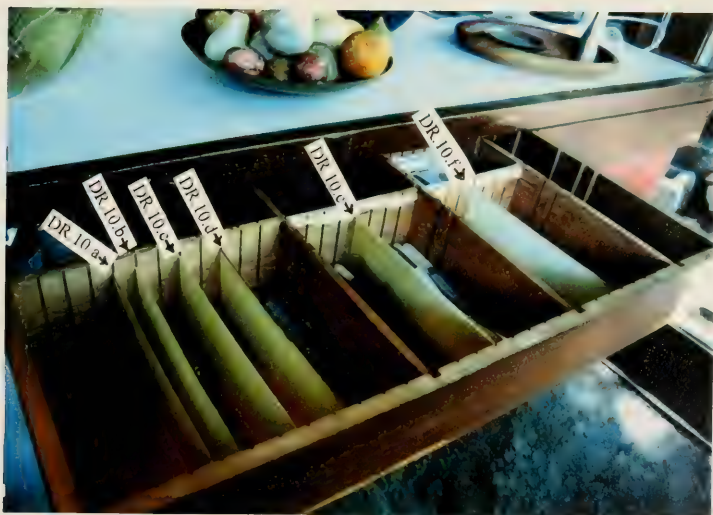
H.5

General Condition: Good
Description: There are no signs of deterioration.
Environmental Factors: 1) *Natural light:* The divider is not generally exposed to sunlight because the drawer is often closed. 2) *Artificial light:* One incandescent light bulb in the chandelier above the dining room table can affect the divider, but the drawer is usually closed. 3) *Heat:* There is a heating vent under this cabinet space. The heat makes the bottom half of the door warm.
Maintenance and Conservation: The divider should not be moved from its guides to prevent potential deformation and possible breakage. Since the drawer is usually closed, problems of deterioration by light are less of an issue. The use of the heating system should be eliminated or at the least kept at low levels and used minimally. The component should be lightly dusted as needed.

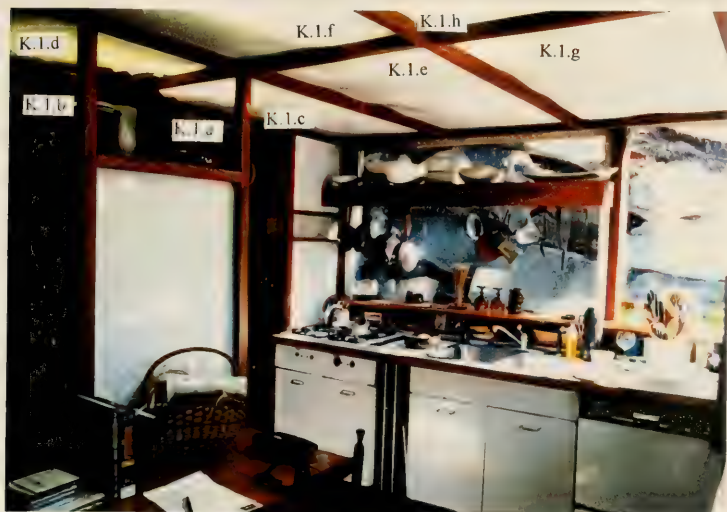
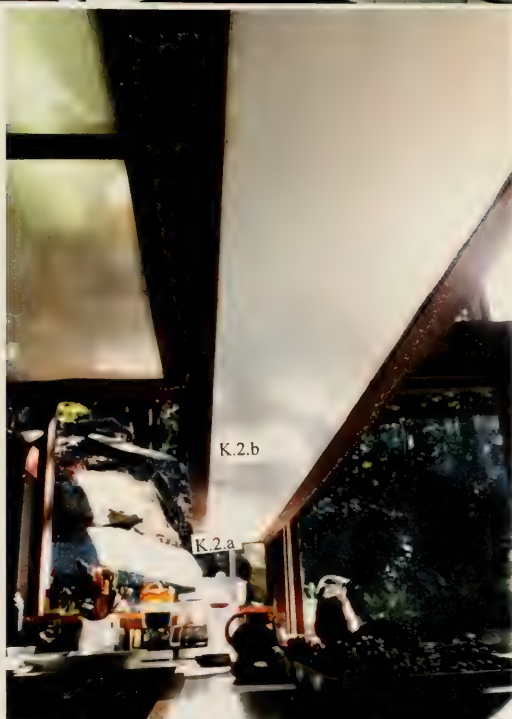
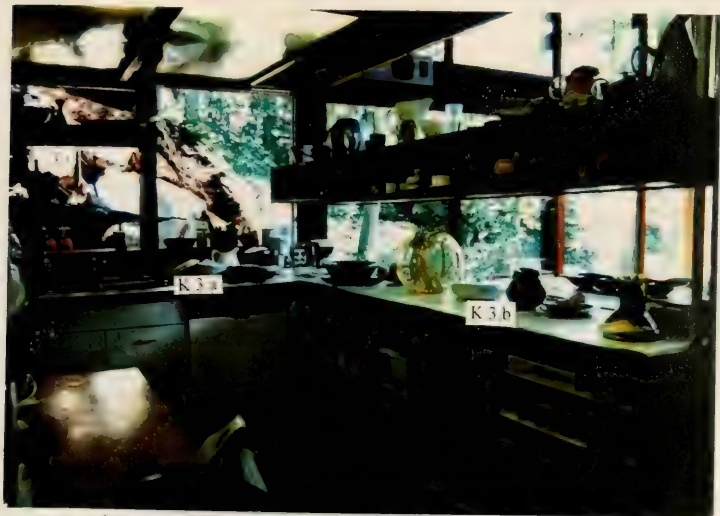
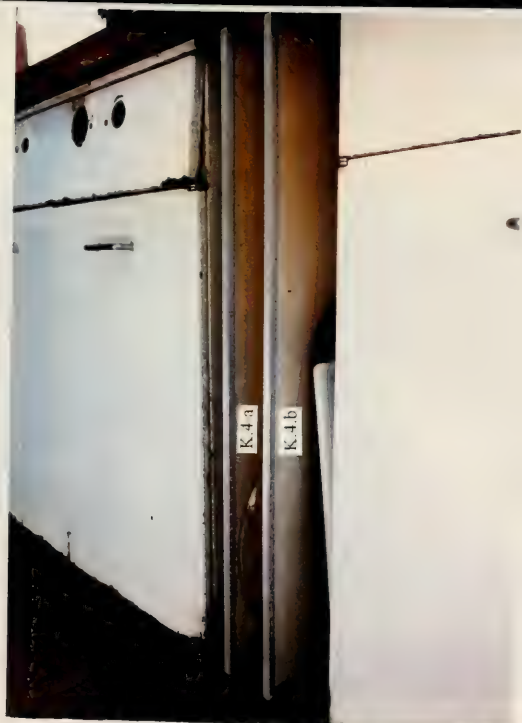
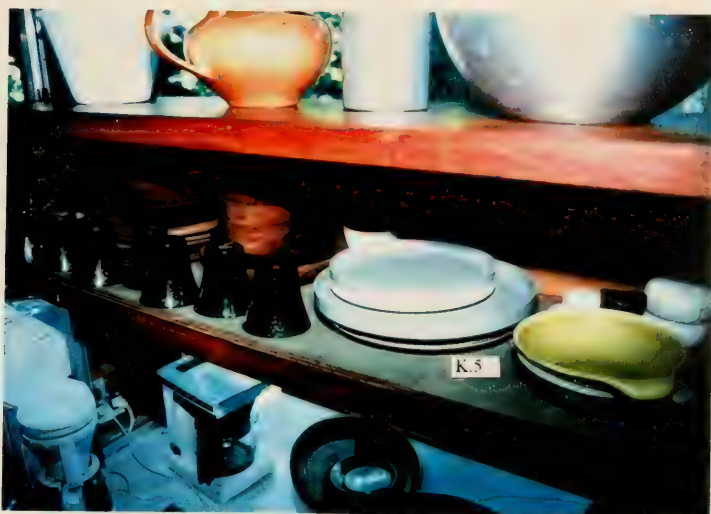
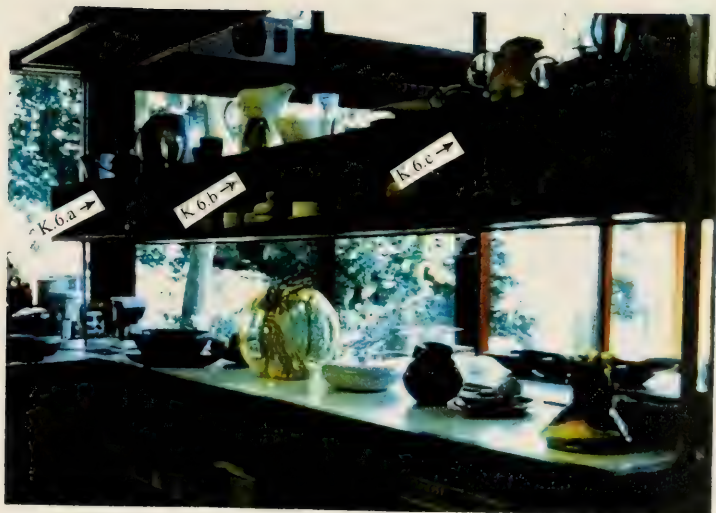
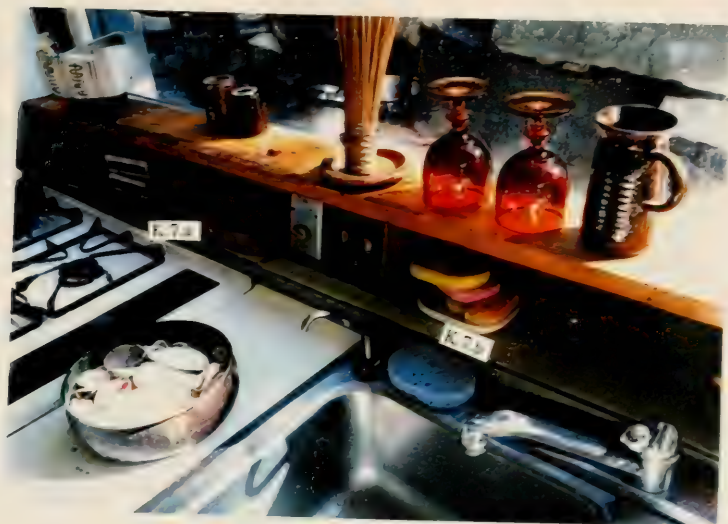
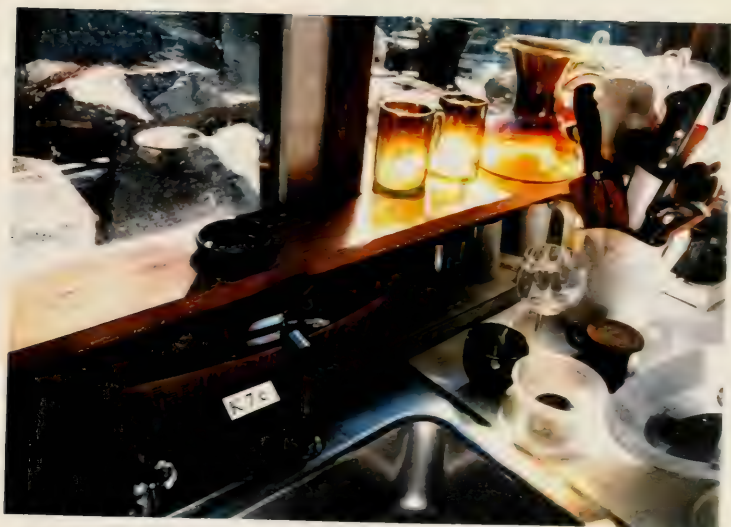
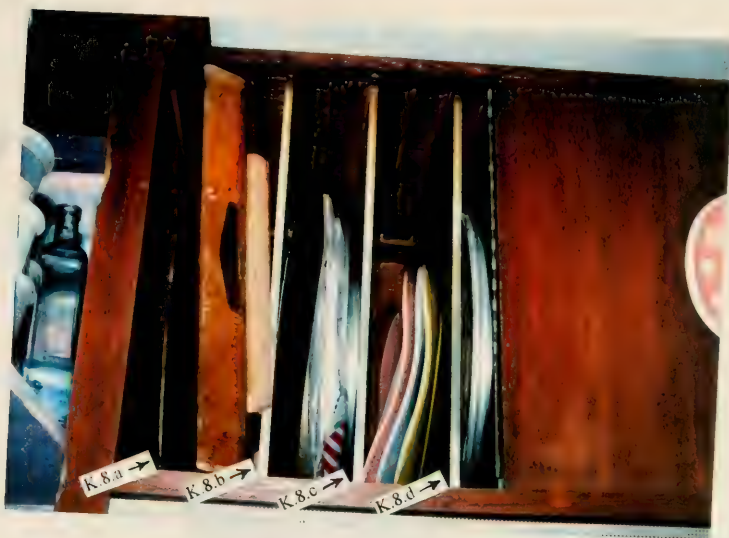
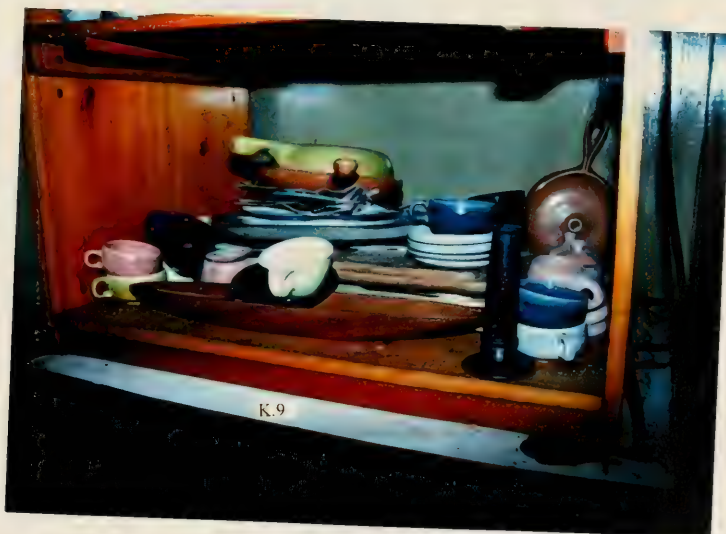
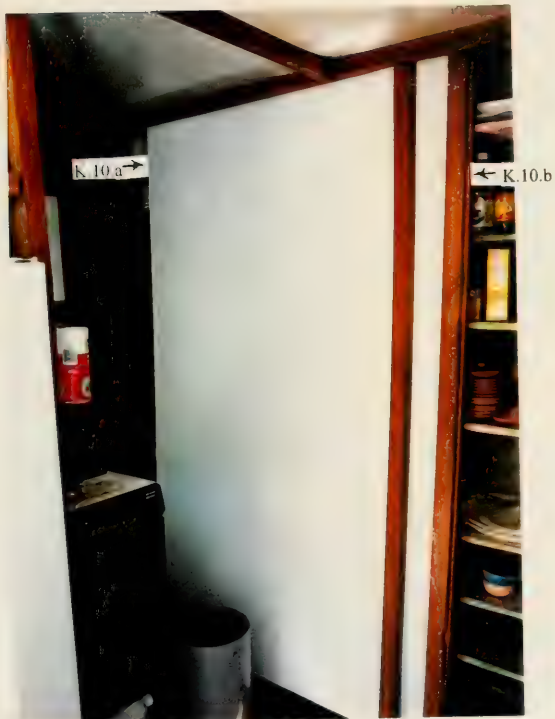
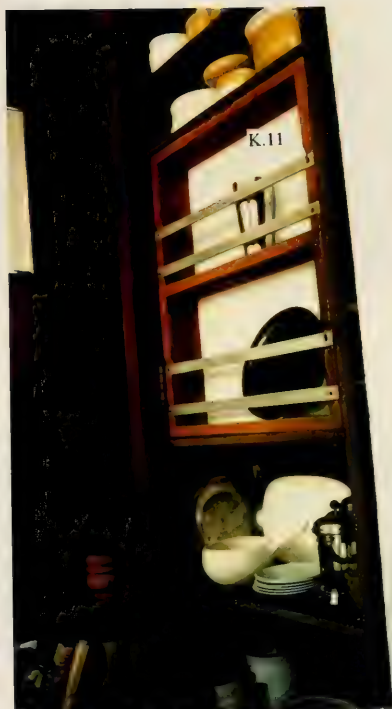
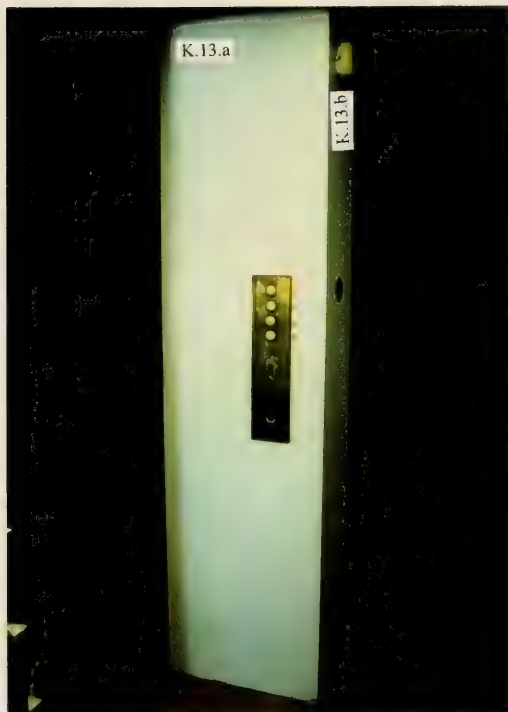
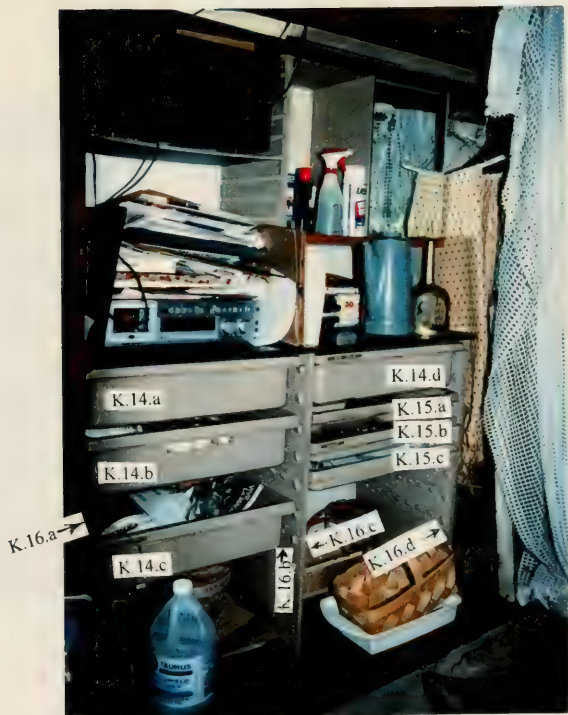
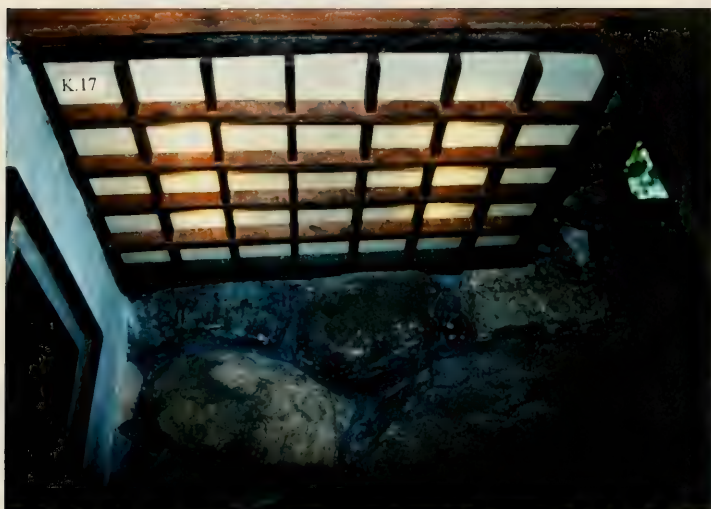
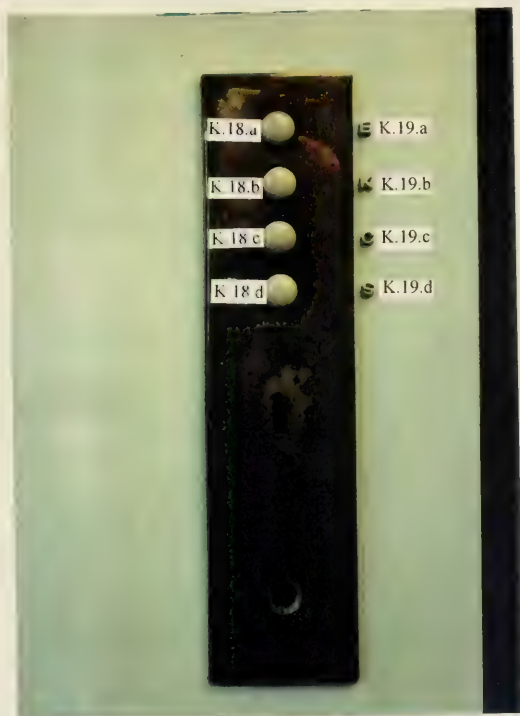
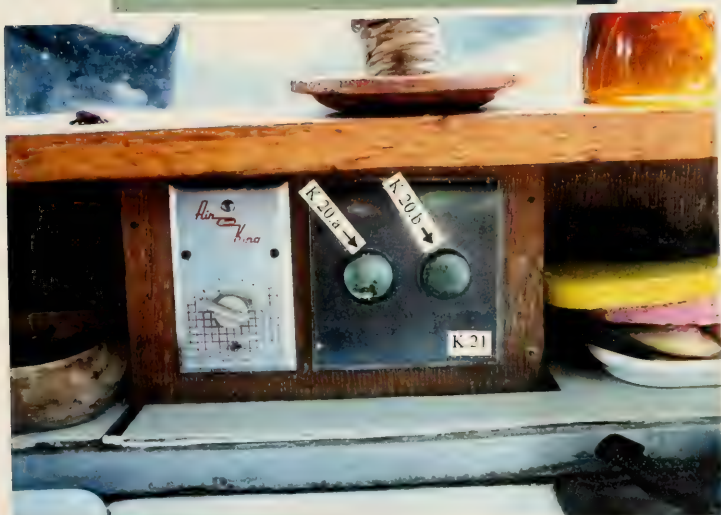
H.6 KITCHEN

Environmental Factors: 1) *Natural light:* There are two story windows with southern exposure in the adjacent dining room. There is some direct affect of this for the component. 2) *Artificial light:* There are several overhead fluorescent lights behind panels at the ceiling of the kitchen, some of which may have an indirect affect. 3) *Moisture:* The kitchen is known to have high levels of moisture. In addition, moisture from the sink and from outdoors is a significant factor.

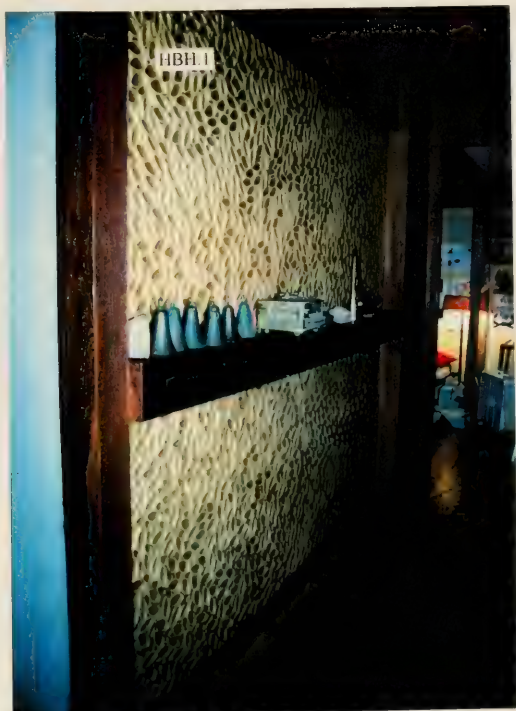
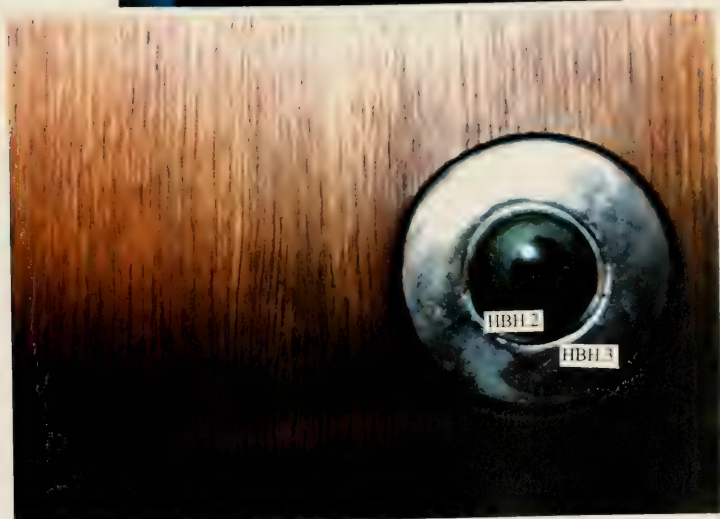
MATERIALS AND CONDITION SURVEY: INTERIOR PLASTIC COMPONENTS AT DRAGON ROCK IN GARRISON, NEW YORK	
Surveyor:	Christeen Taniguchi
Date:	October 17, 1997
Weather:	Cold and sunny
ROOM INFORMATION	
Building:	House
Room:	Harem bedroom hall
Room Number:	H.7
Exposure:	Northeast
MATERIAL DESCRIPTION	
Component:	Light switch plate
Component Number:	HBH.3
Location:	Southwest wall of hall, northwest of the panel
Plastic Type:	(unknown)
Color:	Transparent colorless
Shape:	Donut shaped
Size:	2 1/2" diameter
Other Similar or Identical Elements:	No
Additional Description:	The component surrounds a circular light switch and there is silver colored paper underneath.
Alterations:	No
RESIN MANUFACTURER/PROCESSOR/FABRICATOR INFORMATION	
Resin Trade Name:	(unknown)
Resin Manufacturer:	(unknown)
Processing Method:	(unknown)
Processed Product Trade Name:	(unknown)
Processor:	(unknown)
Fabricator:	Minneapolis-Honeywell Regulator Company; Minneapolis, Minnesota

CONDITION SURVEY	
General Condition:	Good
Description:	The plastic feels slightly rough. There is a platinum colored paper underneath which looks slightly worn.
Environmental Factors:	1) <i>Natural light:</i> The windows facing the component bring in minimal northeast light.
Maintenance and Conservation:	UF3 panels should be attached to the frame of the lights for filtering UV radiation. The component should be lightly dusted as needed.

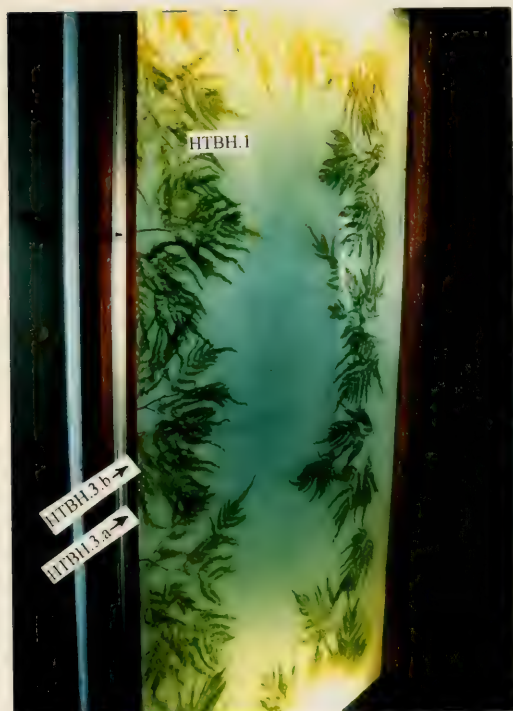
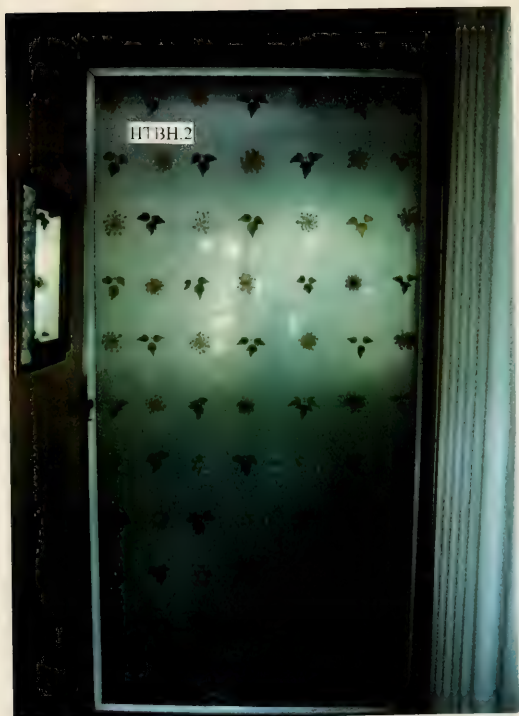
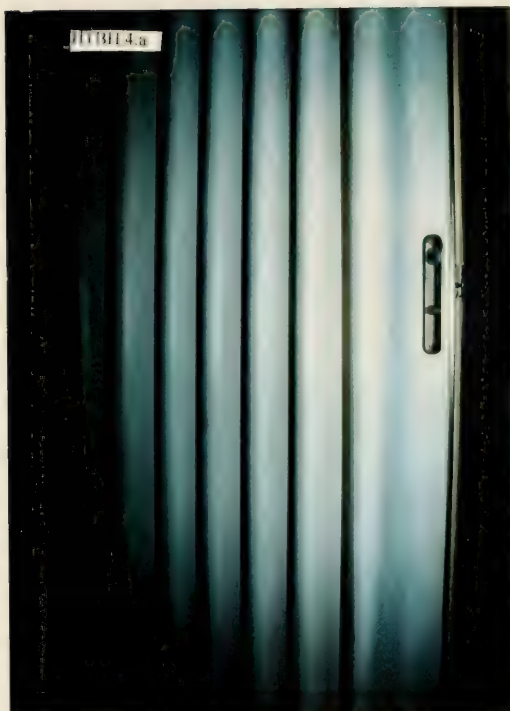
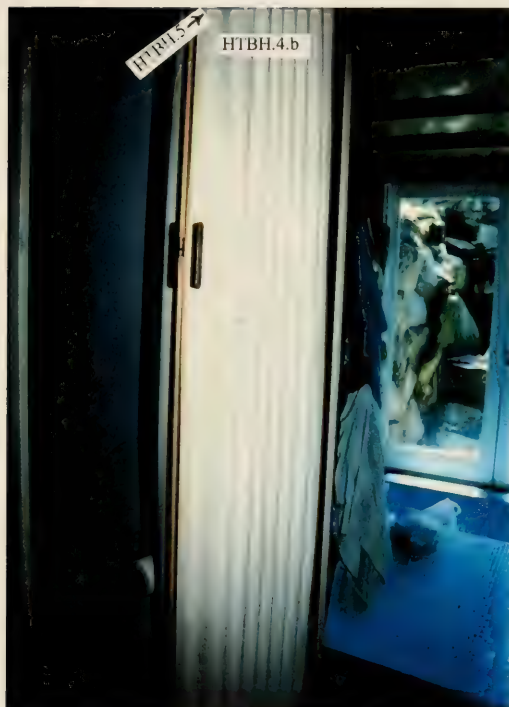
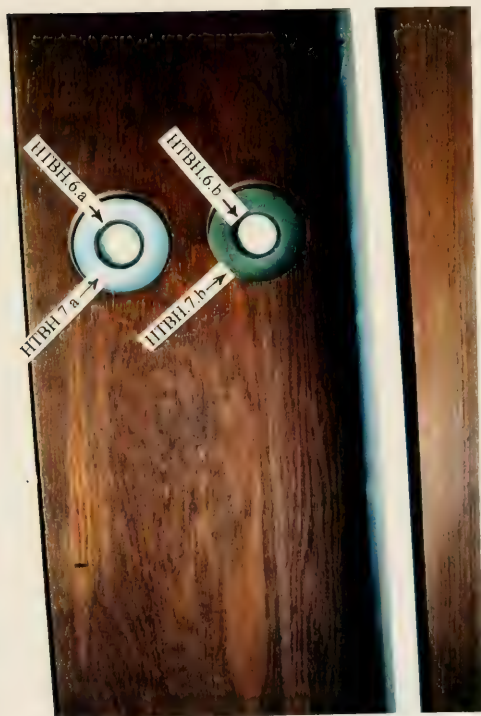
H.8 HAREM TOILET/BATHROOM HALL

Environmental Factors: 1) *Natural light:* There is some effect from the light from the lights with southern exposure. 2) *Artificial light:* There are fluorescent lights in both the toilet and bathroom areas. The bottom light of the toilet is not working. 3) *Moisture:* Steam and moisture from the use of the bathtub/shower and the sink to some extent.

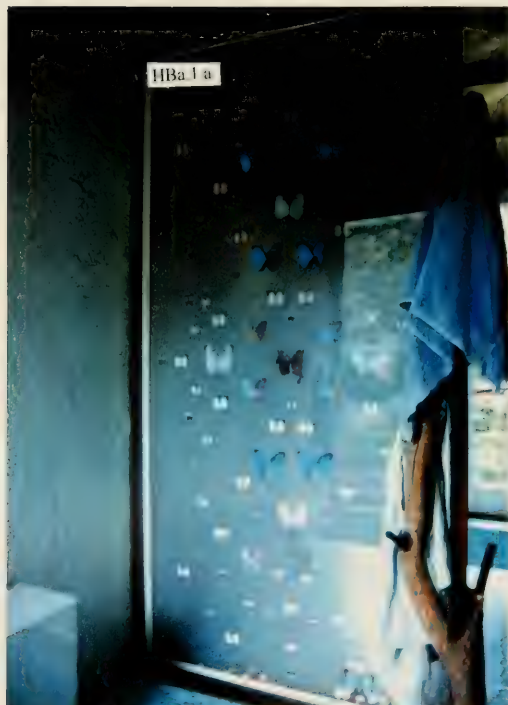
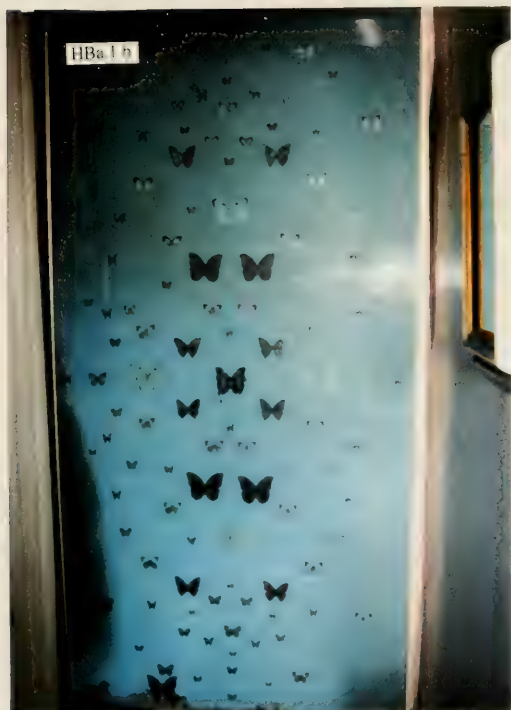
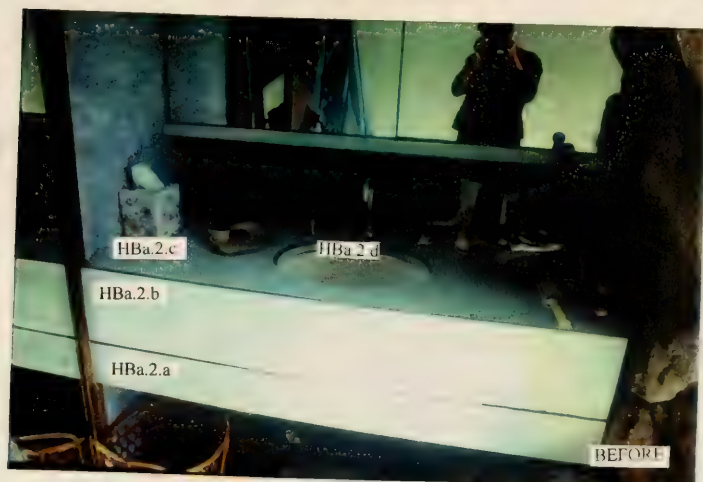
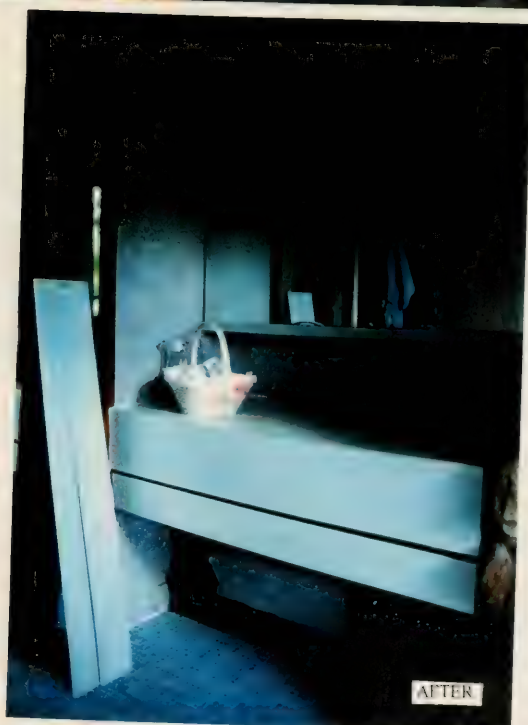
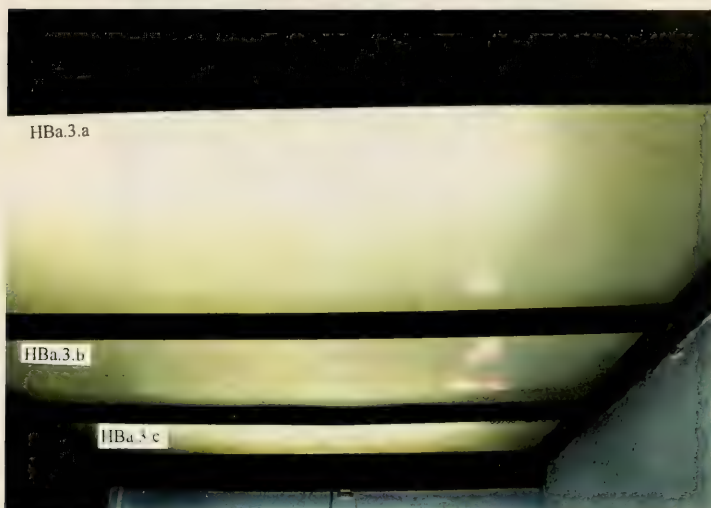
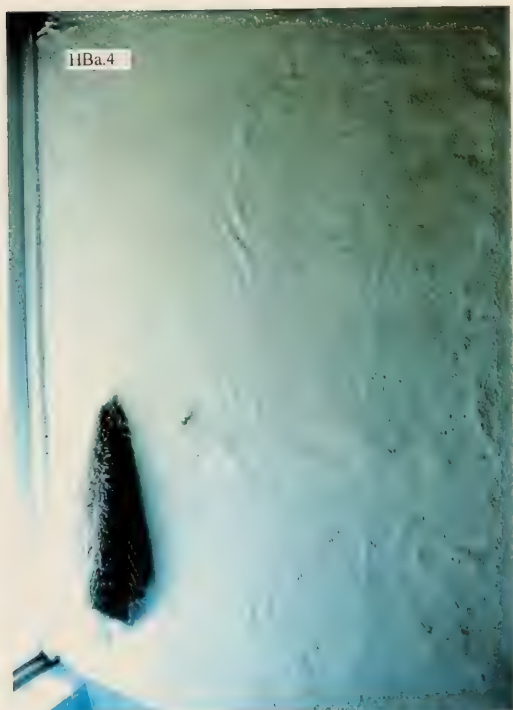
H.9

Environmental Factors: 1) *Natural light:* There is a significant amount of sunlight coming in from the southwest window. If this sliding door is closed, however, there is less effect from sunlight. 2) *Artificial light:* There are fluorescent lights above the ceiling light panels in this room. 3) *Moisture:* Steam and other moisture from the bathtub/shower and the sink.
